## WIPER RELAY REPAIR

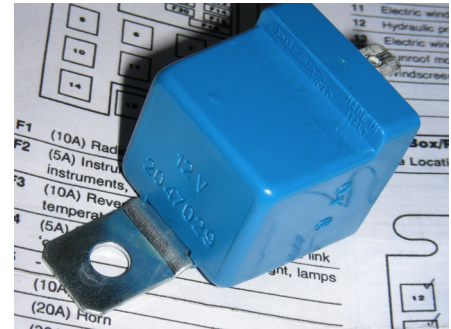
On my Xantia, the front and rear units were of different makes and are externally different; the front unit (right) has a plated steel mounting tag that slots through, and is screwed to, an upstand on the farthest edge of the relay plate. The tag is jammed into a pair of slots moulded on the outside of the blue cover.

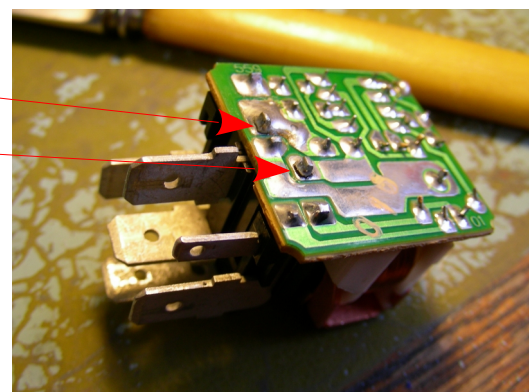
The rear unit is simply a blue cube with the same arrangement of spade connectors and simply plugs into the rear wiper motor, with the electrical spade-connectors providing the only mechanical support. The lack of any other support means that every time the tailgate or hatch is shut, the spades are subjected to a sudden shock load - whip-lash.

Loss of intermittent wipe seems to be a relatively common problem, sometimes the fault itself is intermittent! The failure is usually a complete fracture of the solder joint of one spade connector on the internal Printed Circuit Board (PCB). Once you've found the relay (potentially the hardest part) and removed it, repair is a simple soldering job.

A typical failed relay: the solder joint of one of the spade connectors was partly fractured and that of terminal 2 (relay common contact) was completely fractured.

It's a fairly simple to re-solder the joints, building up a more generous shoulder to spread the load over a large area of copper, but it's vital to avoid any tag getting hot enough to melt or distort the black plastic base that supports and locates the tags.

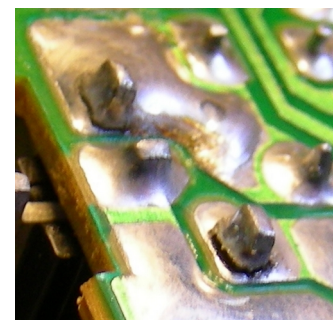
In time, the lack of support will result in a further failure.

Zooming in on those 2 pins, you can see that the fractures are at the edge of the original solder joints and very close to the edges of the hole in the PCB. Repeated violent jerks on the spades have eventually lifted the edges of the (very thin) copper layer away from the PCB base and then from the rest of the copper layer.
