Reference: R271280 29/10/2026 Version 1

Karen Robinson 3008 2WD SUV GT-line 1.6L T/P 120kW THP EAT6 DTW49U VF3M45GYWJS056689

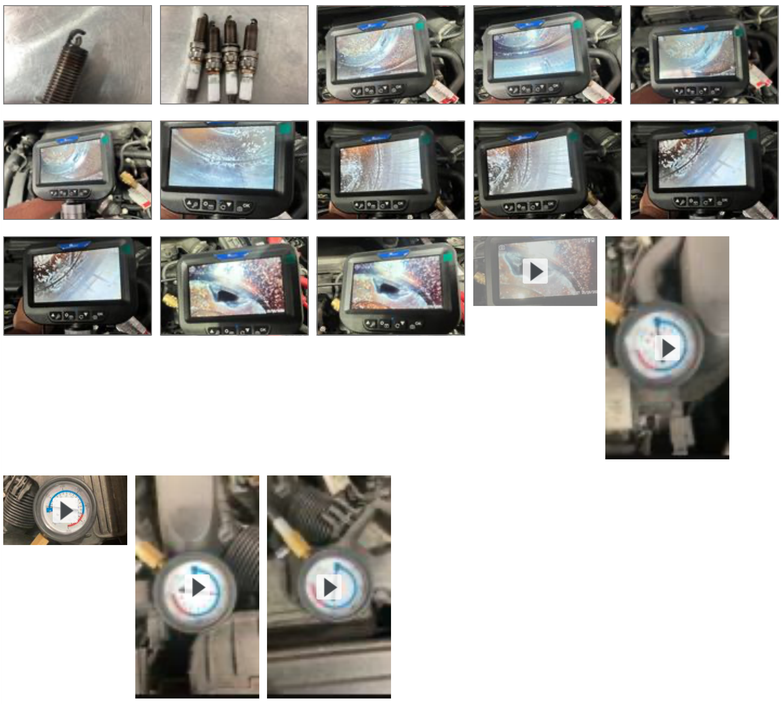
Operation	Description	Price	Authorisation
		DIAGNOSE		Pre-booked
	Engine Components	Scanned for codes, found P1338 00 - Misfire on cylinder 2. Replaced all spark plugs and fault code still there. Checked with endoscope found cylinder 2 has broken and holes in the exhaust valve with deep scratches on cylinder wall. Vehicle requires a new engine to rectify. - THIS COMES WITH 2 YEAR WARRANTY, PART IS COMING FROM FRANCE		Pending Authorisation
